**We are pleased to provide the following APPLICATION NOTE, once again showing the versatility of the UVc DayCor® Corona Detection Camera and the cost savings from its use.**

**The Solarblind DayCor® Camera helps solve a nasty RFI (Radio Frequency Interference) problem.**

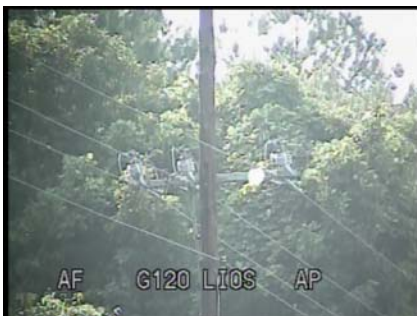
When using the DayCor® camera and looking at the problem pole no indication of Corona or arcing was seen. Pointing the DayCor® camera to the two poles on the left side did not show anything. When aiming the camera to the right to view the other two poles, **a severe Corona indication was detected on the second utility pole.**

Arcing corona seen hundreds of feet away on hazy day.

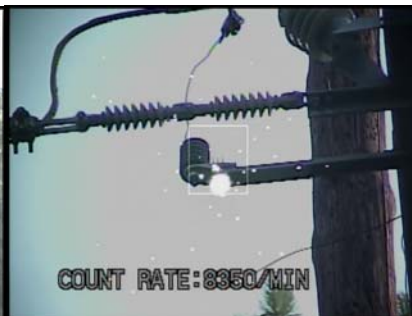
Moving the DayCor® camera to this location for a closer look, arcing was detected at the bottom of a lightning arrester. **The arcing strength was measured with the DayCor® Corona Camera counter and was found have a count rate of 8,000 to 10,000, extremely high!** The location of the arc was between the bottom of the lightning arrester and the support bar. The lightning had shorted out the lightning arrester and burnt out the grounding wire.

The exact corona arcing location

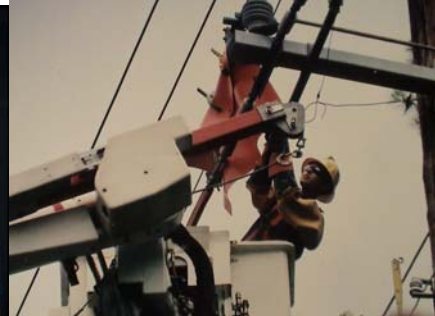
Lineman from EMC takes down the faulty arrester

The local EMC called in one of their bucket trucks and the faulty lightning arrester was disconnected and brought down for evaluation. It had zero Ohm resistance and was discarded. **The Radio Amateur Operator reported that all the radio interference was now gone and the noise level was measured to be below S1.**

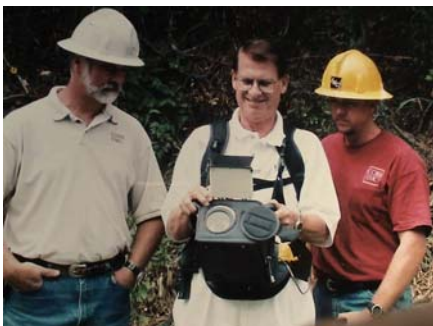
EMC crew studies the corona camera image
