Contaminated insulators and bushings can create havoc with the delivery of our electricity! Dirty or damaged insulators are susceptible to Electrical Corona and Arcing causing flashover & downed lines.

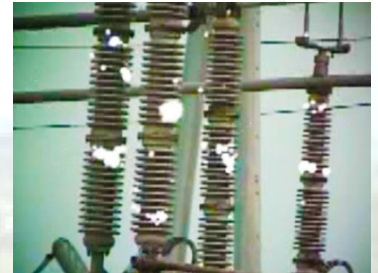
The pictures above show pictures from a substation with heavy Electrical Corona on most of the insulators and bushings. It was recorded with a DayCor® Solarblind Corona Camera where they had major problems with contamination.

A cooling tower close to the substation sent dirty water mist over the substation and all its insulators. It got so bad that they had several repeat flash-overs that shut down large parts of the electric supply to a nearby city. The DayCor® camera could easily pinpoint the dirty insulators. After power wash all were clean and no Electrical Corona and Arcing could be seen.
