## Dear Electric Utility Professional.

With the advent of Non Ceramic High Voltage Insulators, i.e. Insulators made of Plastic Polymer; a new importance is reached in the detection and eradication of Electric Corona on high-tension equipment such as overhead power lines and substations.

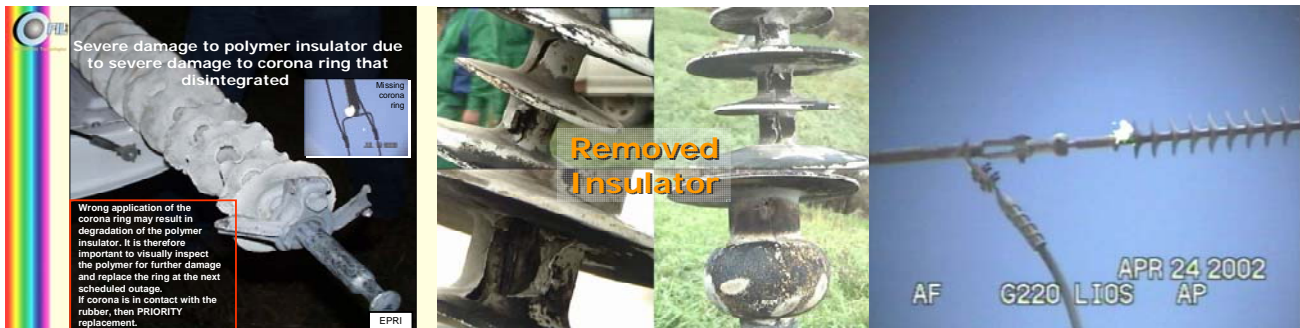
Above: Polymer Insulators with Corona Damage

Above: Missing Corona Ring

Many installed polymer insulators do not have protection for Corona damage. Some insulators are not equipped with grading Corona rings and others have damaged or missing rings. Some grading Corona rings are not installed correctly or may have the wrong design or size.

The invisible Corona on a polymer insulator and its hardware can seriously damage the insulator, resulting in flash-over or flash-under conditions. Electric Corona on a polymer insulator can damage the sheds and the membrane keeping the fiberglass rod system intact. If this happens pin holes can let moisture inside the protective membrane and the insulator will have an internal short. The Corona may also damage the insulator so that it sheers off. The Corona can corrode the insulator ends and jeopardize the structural integrity of the insulator. Electric Corona together with the Nitrogen and moisture in the air **produces Ozone and Nitric Acid! A no-no for Polymers.**

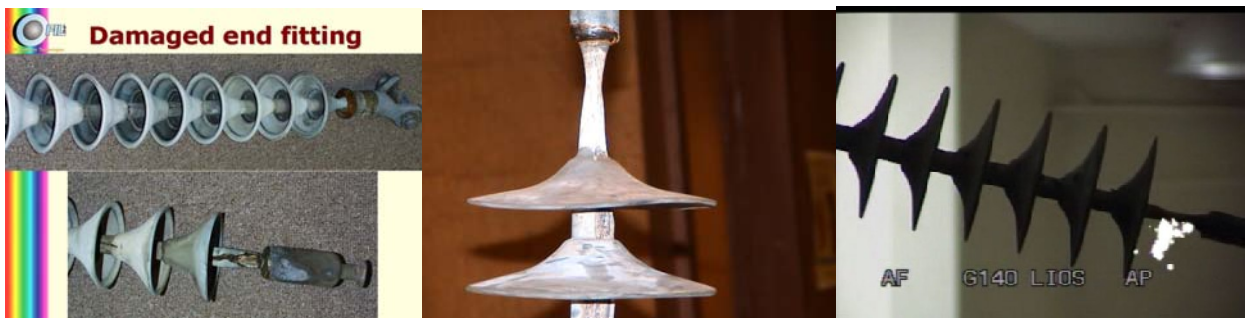
Above: Severe loss of material due to Corona.

Above: Faulty 110 kV Insulator Removed & Tested at 50 kV showing Corona!

In any of these cases, the possibility of a line drop is **real** and could happen at any time when Corona is existent on the insulator and damage has been done. The early detection of Electrical Corona is extremely important to keep the integrity of the electrical grid.
